# ALPHA

## TROUBLESHOOTING

Looms

Looms  
DRIVE

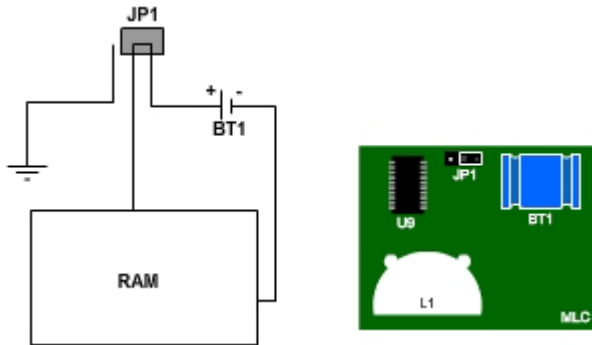
picture 1 "normal"

Return the JP1 to "normal mode".

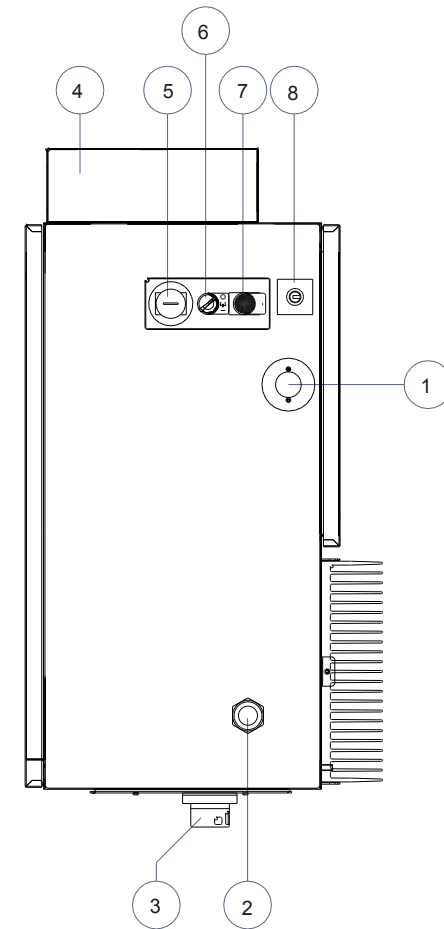
Main box upper view

- 1: Hole for signal lamp (only for dobby looms).
- 2: Input power cable from upper side.
- 3: Main switch control lever.
- 4: LOEPFE thermo cutter panel.
- 5: S01 emergency push-button.
- 6: S03 Suction motor enabling (only for powered motor).
- 7: H01 green light (power activation) KQ01(power ON).
- 8: Temperature selector for PROMATECH thermo cutter.

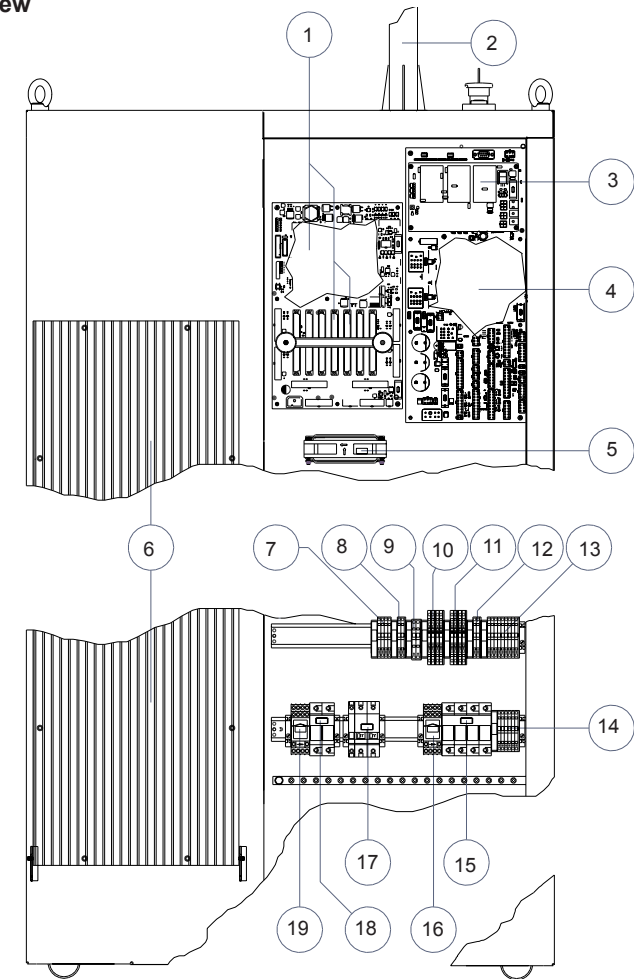
**TAB. C**  
Main box back view

| 1: MHD card with MHP cards | 11: X24DC clamps |

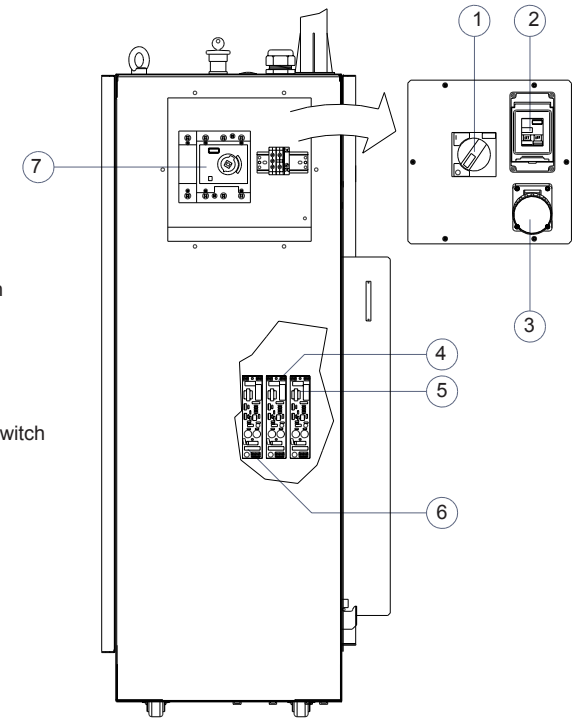
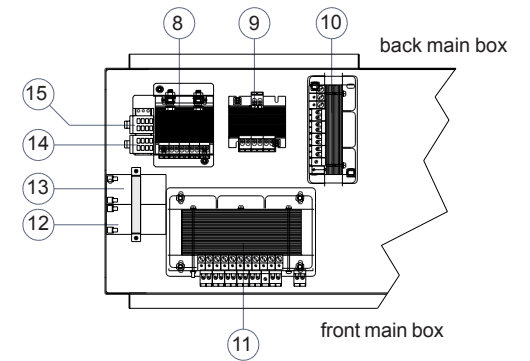
### Main box lateral and bottom view

- 1: Main switch control lever.
- 2: QS02 magnetothermal switch socket 220V
- 3: socket 220V
- 4: A02 card
- 5: A03 card
- 6: A01 card
- 7: QS01 Main magnetothermal switch
- 8: T04 transformer
- 9: T03 transformer
- 10: T05 transformer
- 11: T01 transformer
- 12: GB1 battery
- 13: GB2 battery
- 14: KT01 relay
- 15: KT02 relay
